US Army Corps
of Engineers

TECHNICAL REPORT REMR-CS-4

REPAIR OF WATERSTOP FAILURES: CASE HISTORIES

James E. McDonald

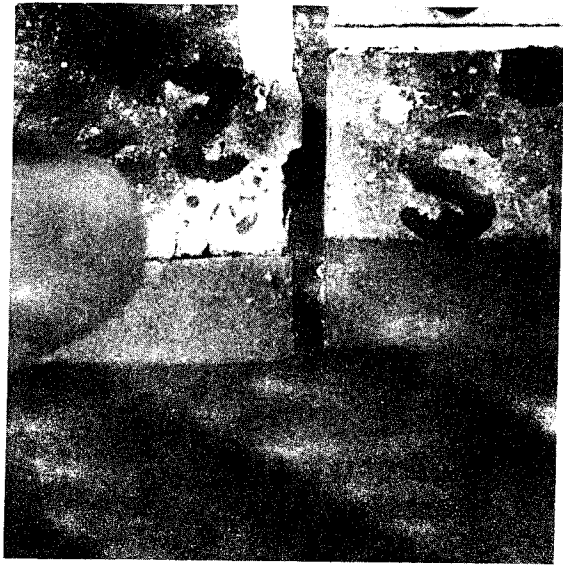
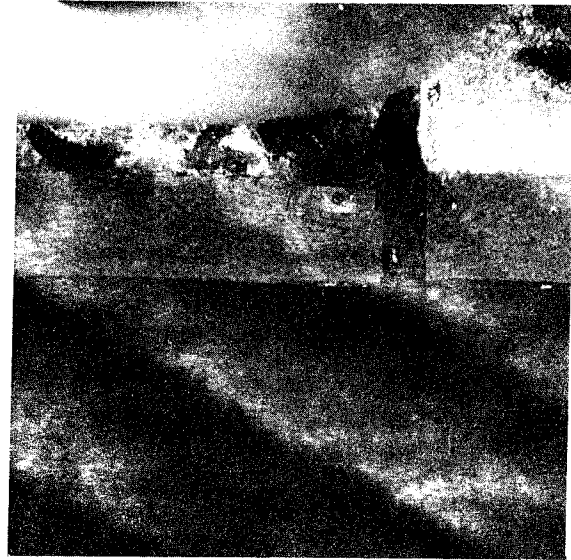
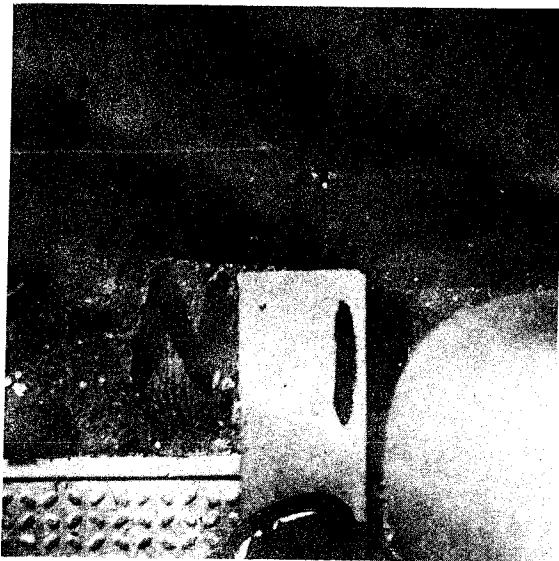
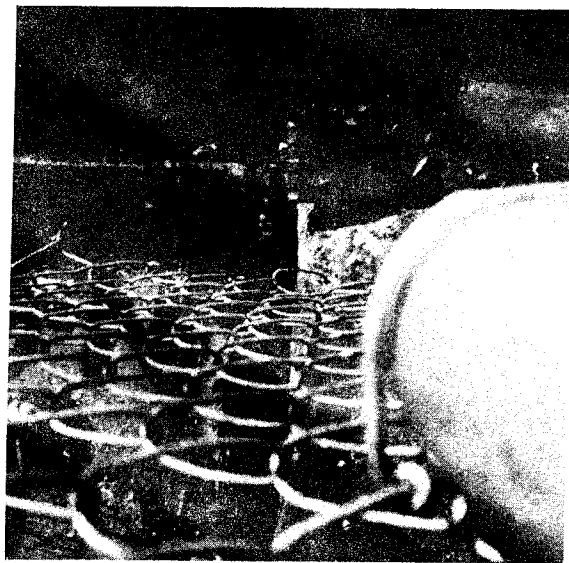
17. The joints between lock chamber monoliths and those between approach monoliths appeared to be in good condition with no unusual openings or offsets when inspected in 1973. However, joints between the gate bay monoliths and adjacent monoliths showed visual evidence of considerable movement (Figures 3 and 4). Also, there were indications that considerable water passed through the joints between the west gate bay monolith and adjacent chamber monoliths during the recent high water (Figure 5). Gate bay joint movements as measured in October 1973 are shown in Figures 6 and 7. No joint repairs were considered necessary at the time; however, repairs during the next scheduled dewatering in 1978 were anticipated.

Figure 3. Movement between east gate bay monolith and adjacent monoliths as viewed from top of lock wall, November 1973, Algiers Lock

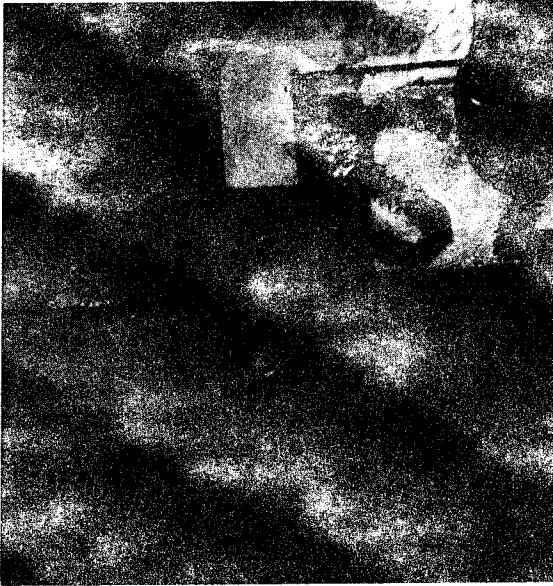
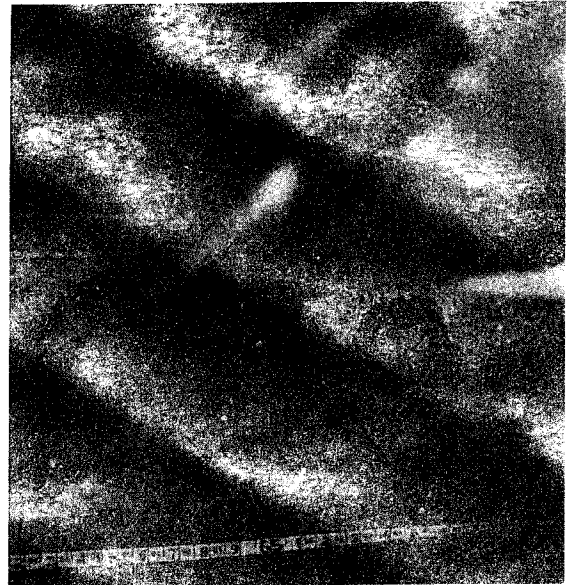
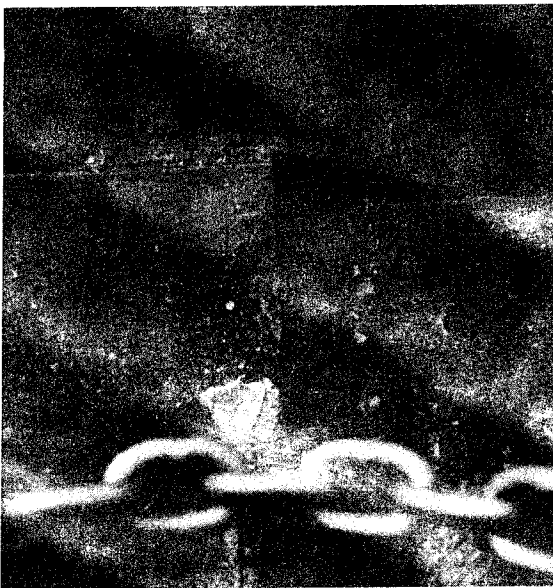
Figure 4. Movement between west gate bay monolith and adjacent monoliths as viewed from top of lock wall, November 1973, Algiers Lock

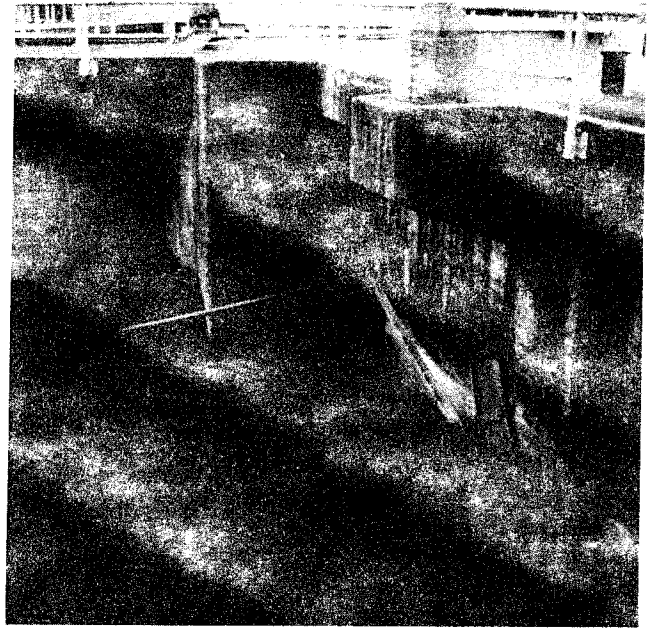
Figure 5. Joints between west gate bay monolith and adjacent chamber monoliths, November 1973, Algiers Lock

19. Joints between the west gate bay and adjacent chamber monoliths were leaking severely when inspected in 1979. Although small dikes had been constructed on the landside of the walls to confine the leakage, the leakage was so severe that the dike on the southeast side of the wall was usually overtopped when the lock chamber was full.

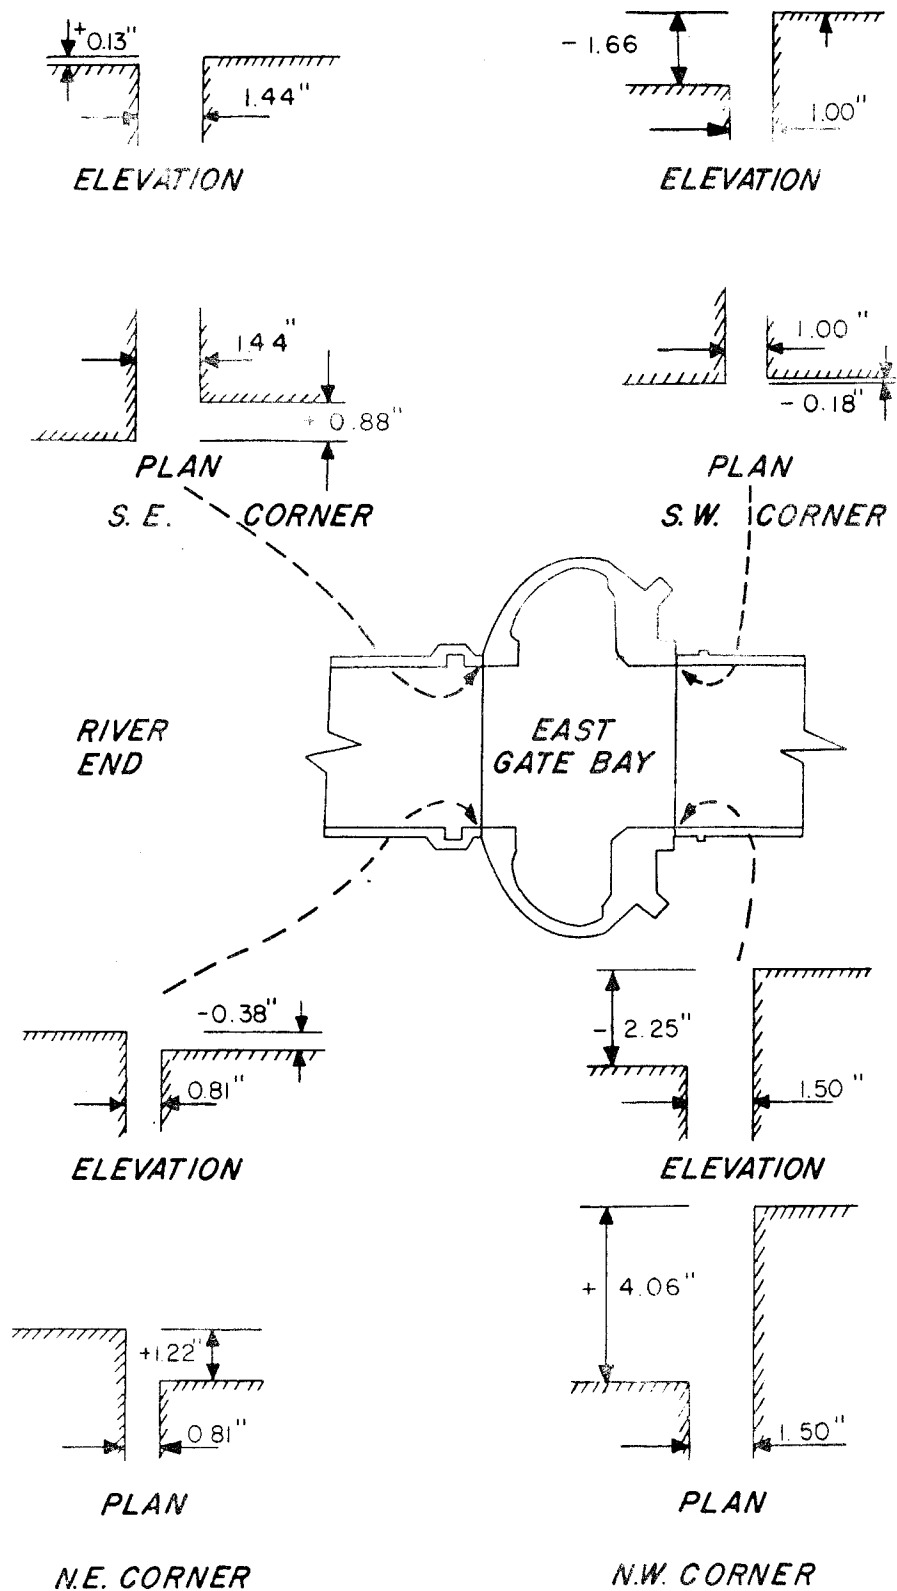
Figure 6. East gate bay joint movements, October 1973, Algiers lock

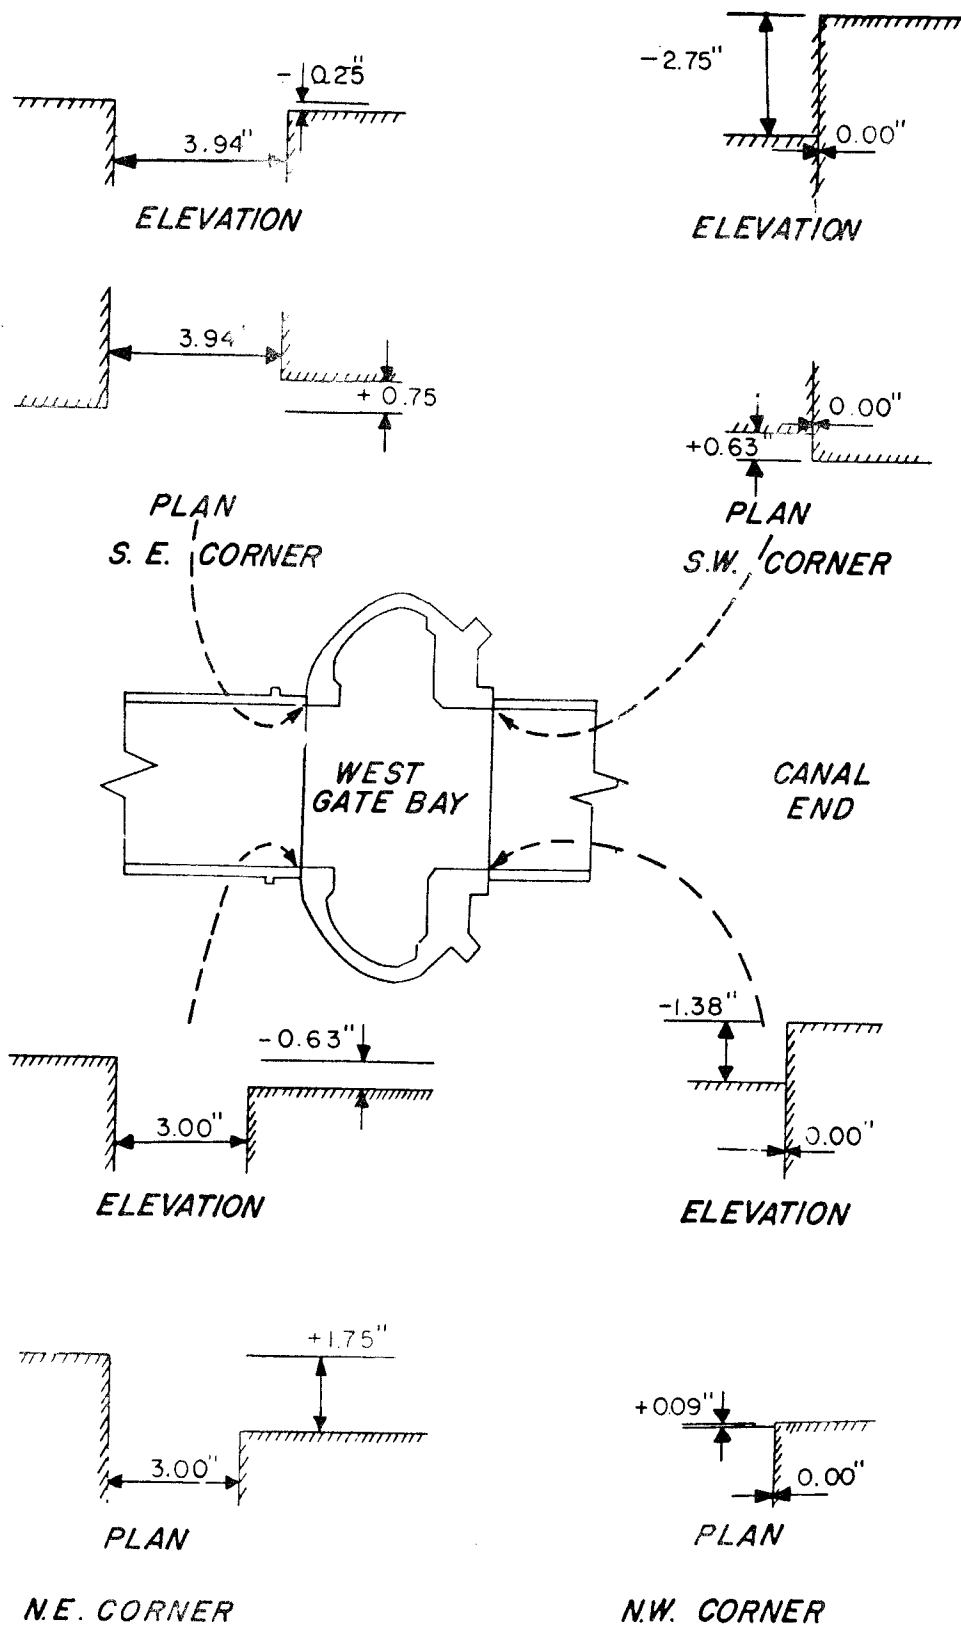
Figure 7. West gate bay joint movements, October 1973, Algiers Lock

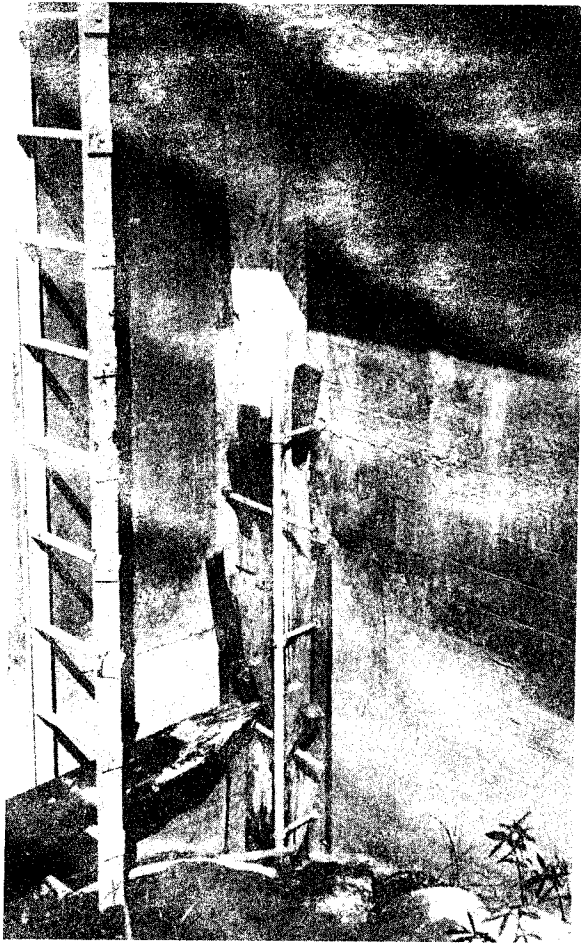
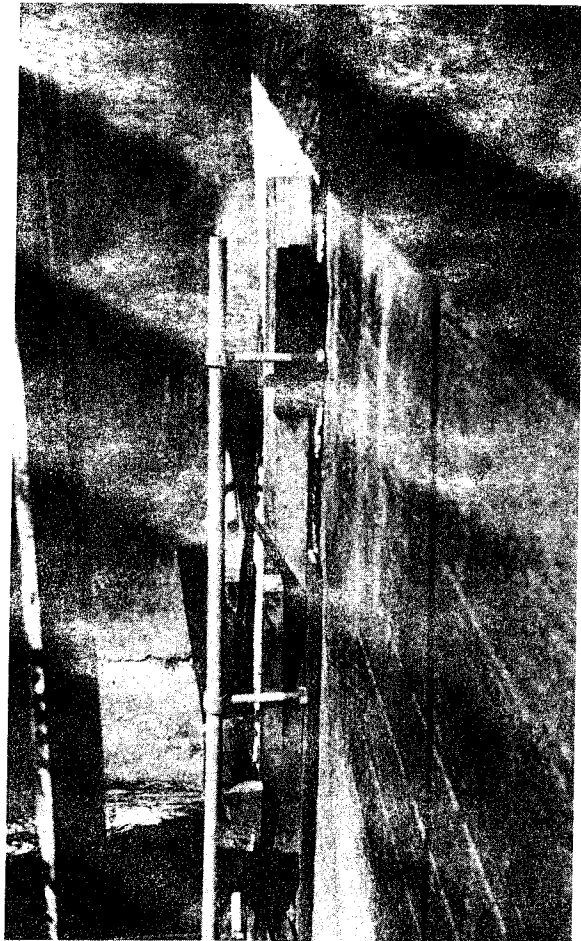
21. The exposed upper portion of the external rubber waterstop installed in 1959 apparently deteriorated with time allowing considerable water leakage through the joint during high water stages. During the high river stages in the spring of 1983, temporary steps were taken to prevent leakage through the deteriorated rubber strip on the south wall. This involved construction of a small wooden cofferdam adjacent to the joint which reduced leakage during high river stages. Leakage was effectively controlled eventually by wedging Styrofoam into and against the opening (Figure 8). In February 1985, partial repairs were made to the landside of the joints in the north and south lock walls between monoliths 35 and 36 by replacing the deteriorated top part of the rubber pad and metal strips with similar materials.

Figure 8. Styrofoam applied over existing rubber waterstop, Algiers Lock

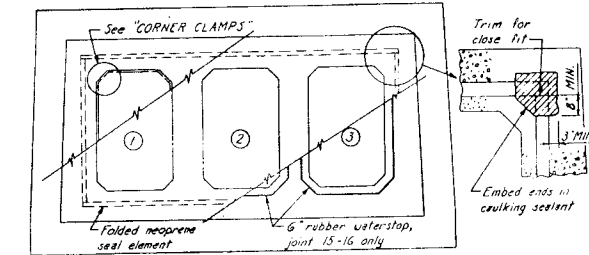
settled about 4.1 ft and elongated 1.89 ft. This resulted in the opening of a number of joints with a maximum joint opening of 12-3/4 in. Major repairs were required on eight joints and seven joints required minor remedial measures to repair ruptured waterstops and reseal the joints. This work was accomplished by the Operations and Maintenance (O&M) Branch.

27. Several repair techniques were used depending on the width of the joint opening. Details of the various repair techniques including material specifications are shown in Figure 13. A new 6-in. rubber waterstop was installed in the joint (15/16) with the maximum opening. Where joint openings were in the range of 1 to 7 in., a 1/2- by 6-in. neoprene seal element shaped in a "U" configuration was placed in the joint as a replacement waterstop. Following placement of polyethylene packing at the convex fold of the seal element, the joint was filled with a sanded cement grout. A 3/8- by 12-in. neoprene diaphragm was then anchored across the joints. Those joints with smaller openings were typically repaired with caulking sealant.

Figure 13. Repair details, Kirwan Dam

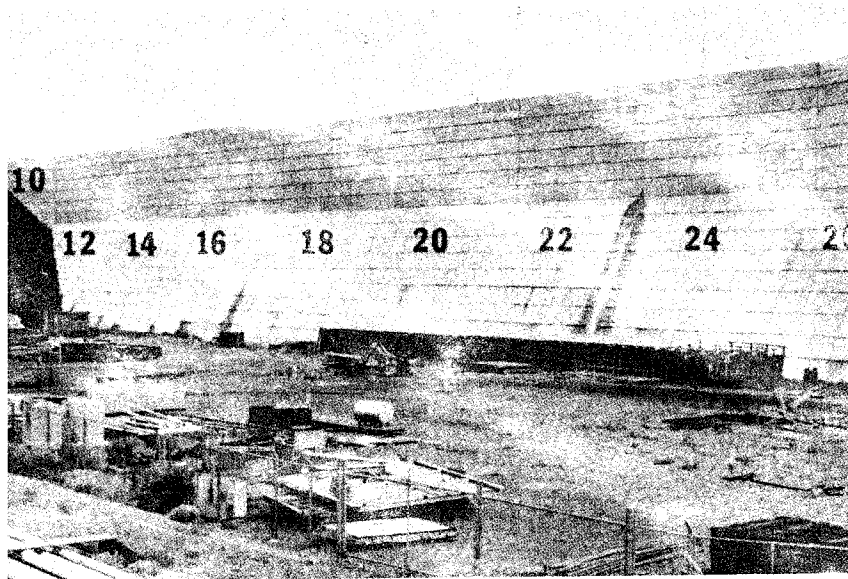
a. Overall view

84. In October 1972, leakage was noted at monolith joints 10/12, 12/14, 16/18, 22/24, 24/26, and 28/30 for the landside lock wall and at 21/23, 23/25, 25/27, and 27/29 for the riverside wall. All except monolith joints 10/12, 12/14, and 22/24 had been repaired in May 1971. Leakage from the landside lock wall with the lock full of water is shown in Figure 28. Leakage apparently entered the landward backfill and some subsidence was reported.

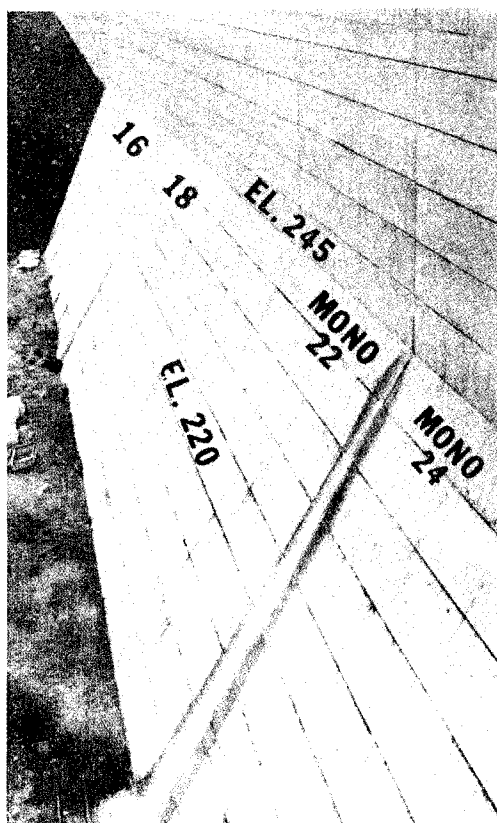
b. Closeup of monolith joint 22/24

Figure 28. Landside lockwall leakage, John Day Lock, October 1972

Leakage from monoliths 16/18 and 22/24 appeared on the surface of the back side of the wall at elevations 220 and 245 ft, respectively. Measured deflections in excess of 1/2 in. were reported for individual lock monoliths (Figure 29).

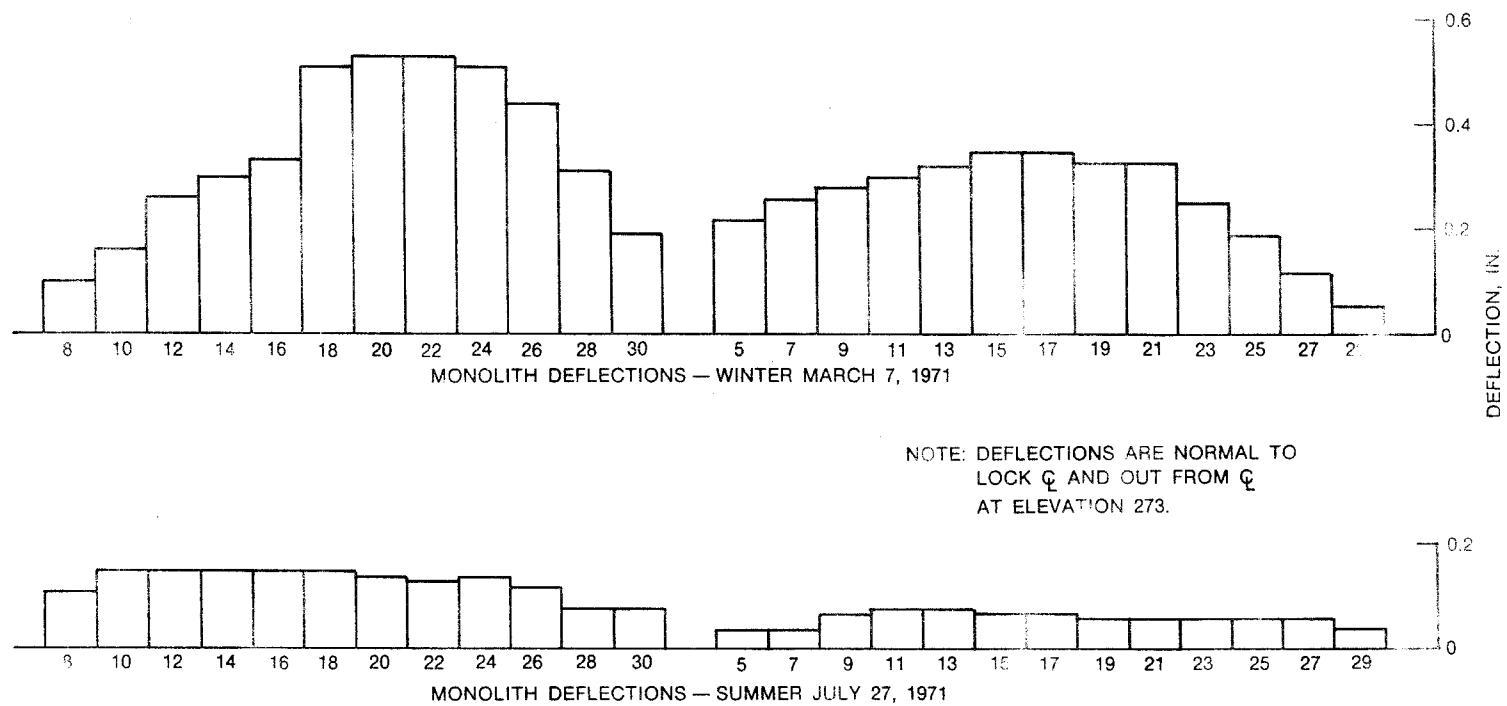
Figure 29. Monolith deflections due to lockage water loading, John Day Lock

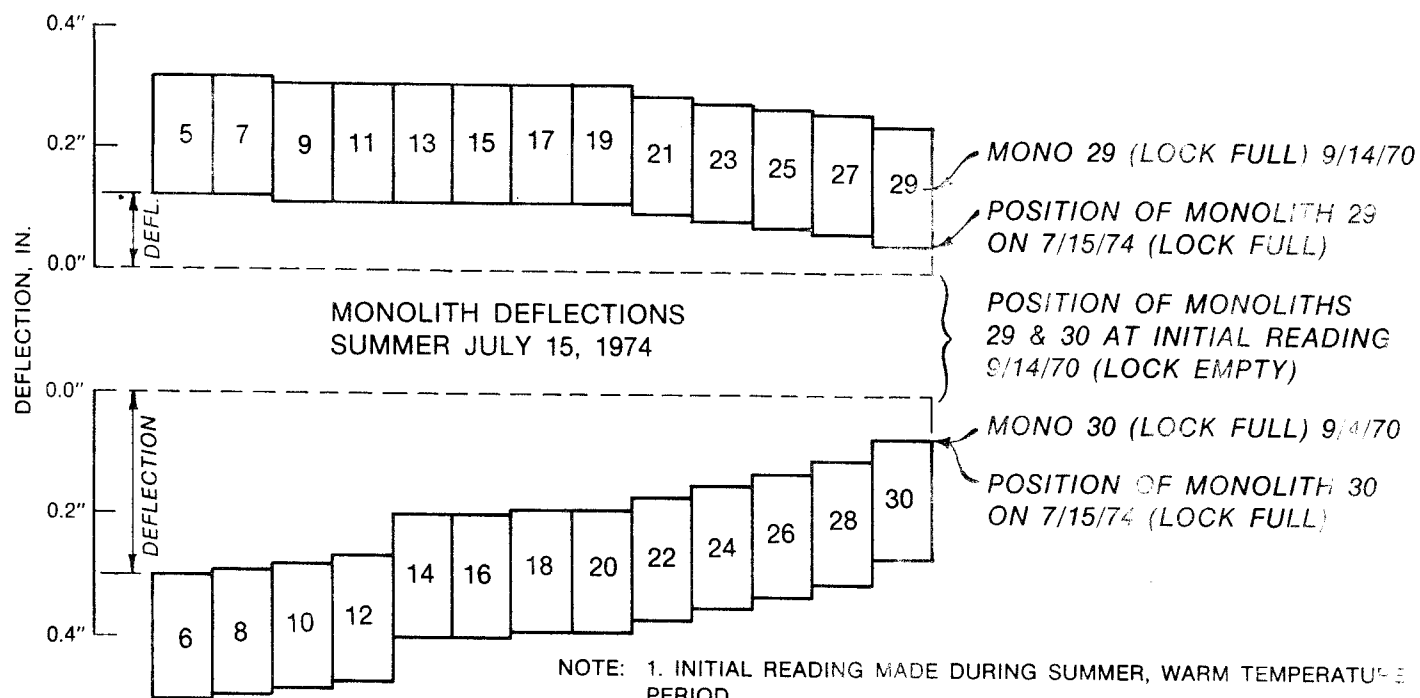
Figure 30. Lock monolith deflections, summer conditions, John Day Lock

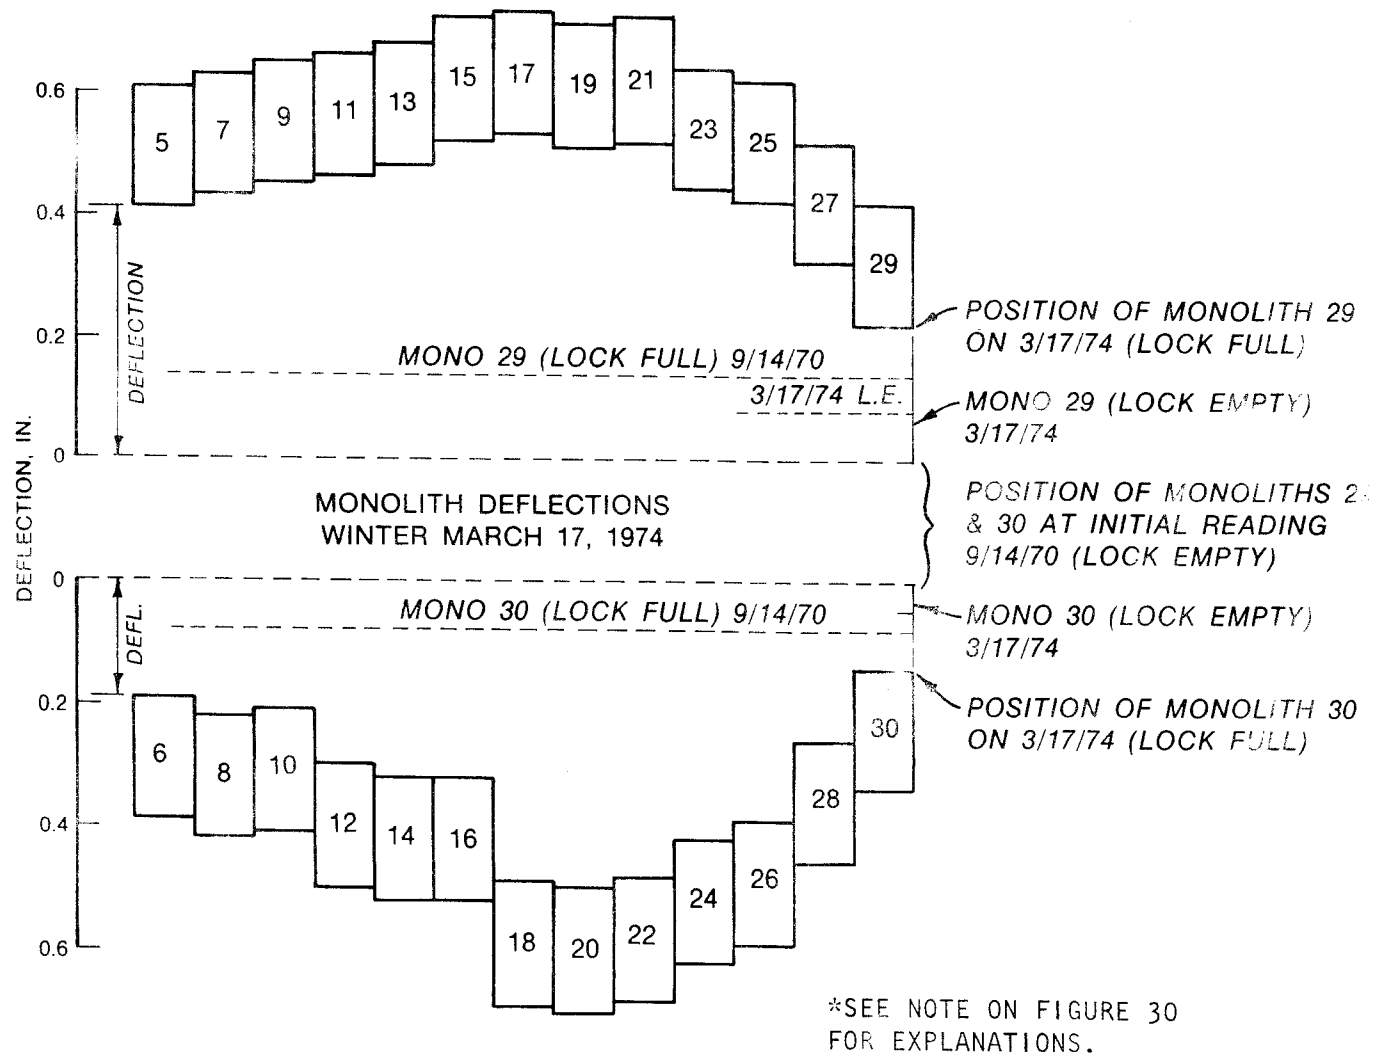
Figure 31. Lock monolith deflections, winter conditions, John Day Lock

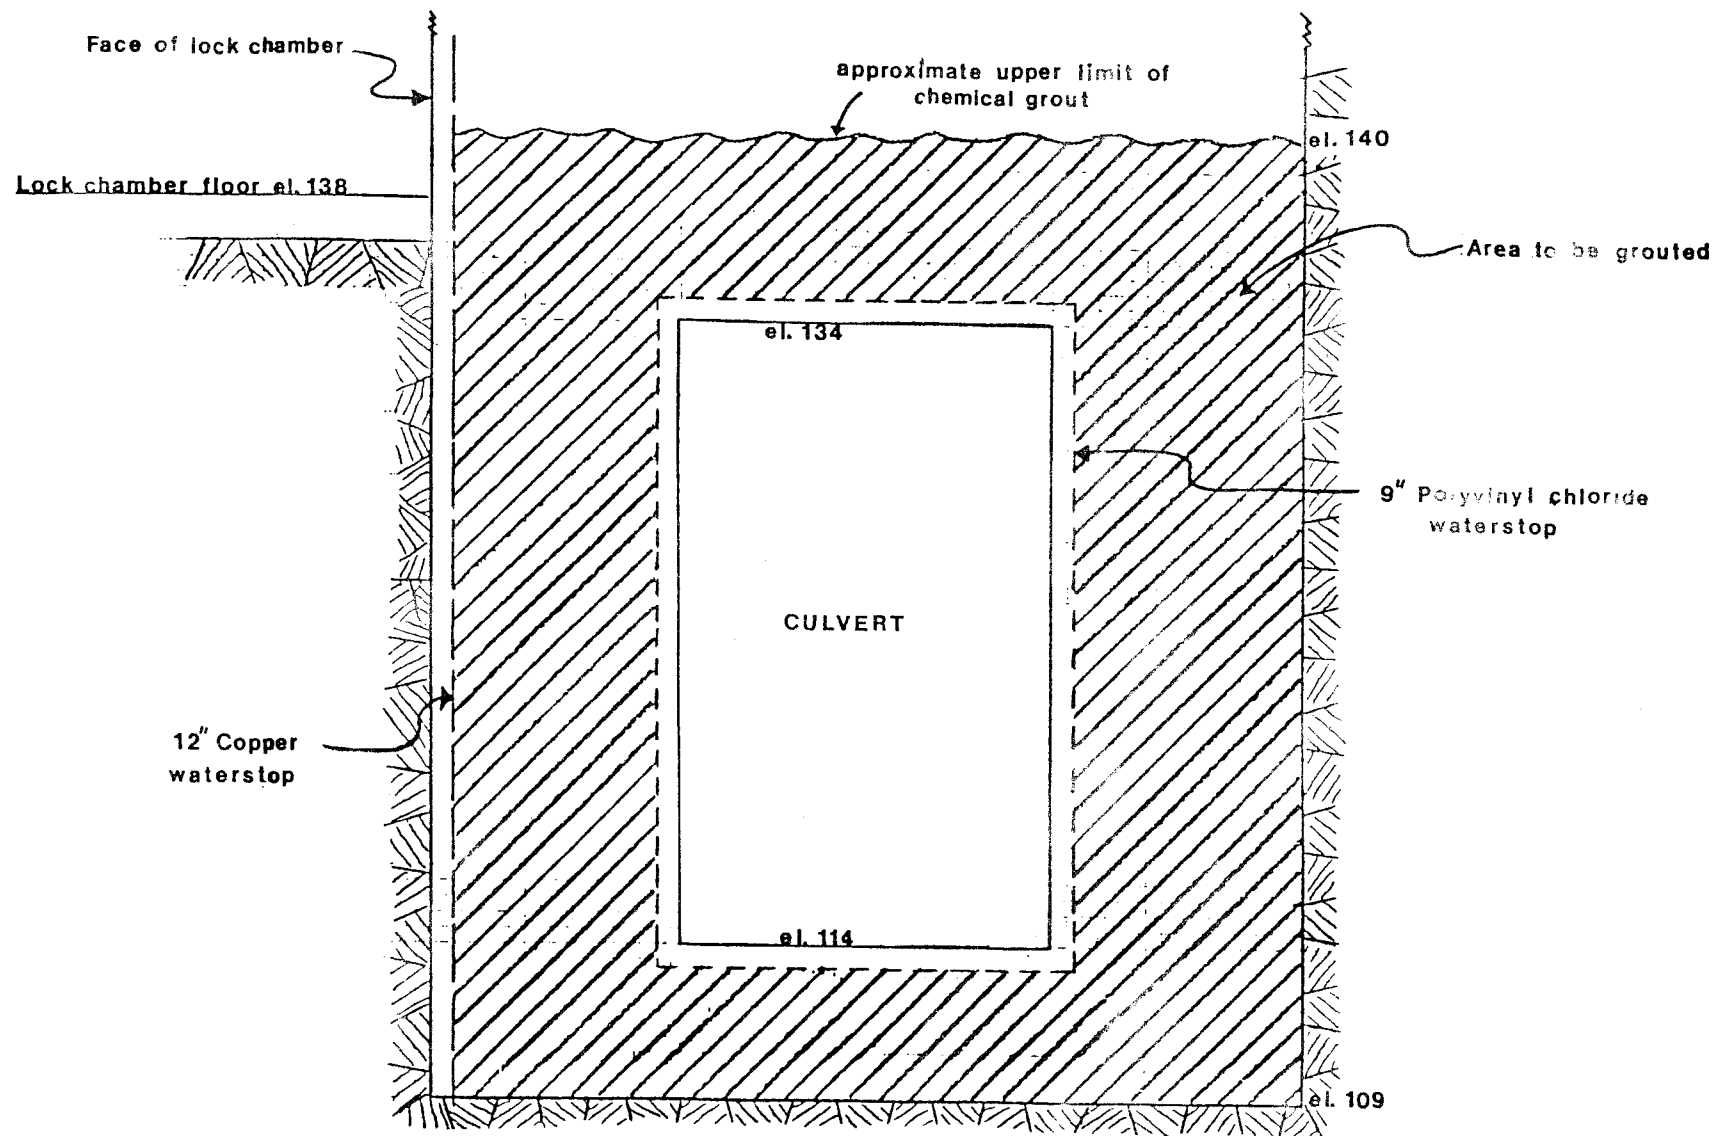
92. Monolith joints 28/30, 18/20, 16/18, 14/16, 12/14, and 10/12 in the north (landside) emptying and filling culvert (Figure 32) were repaired in 1982 using chemical grout. Also, a crack in the ceiling of monolith 10 between joint 10/12 and the bulkhead slot was chemically grouted.

Figure 32. Detail of culvert area to be grouted, John Day Lock

93. EX-size drill holes were evenly spaced around the culvert approximately 1 ft from the joint. Holes were drilled from inside the culvert at an angle of 65 degrees to intersect the joint behind the existing waterstop. All drilling was done by the Government.

94. 3M Company's hydrophilic polyurethane gel (CR-250) was specified for the repair. The polymer grout was mixed at a ratio of 1 gal polymer to 7.75 gal of water. An accelerator (CR-251) and a shrinkage control agent (CR-252) were added to the fluid grout. Also, diatomaceous earth (Celite 209) was added in the amount of 6 percent by weight of the fluid grout. Uncoiled oakum saturated in hydrophilic polyurethane foam (CR-202) was used on joints 10/12 and 28/30 to control the flow prior to injections of the CR-250 grout.

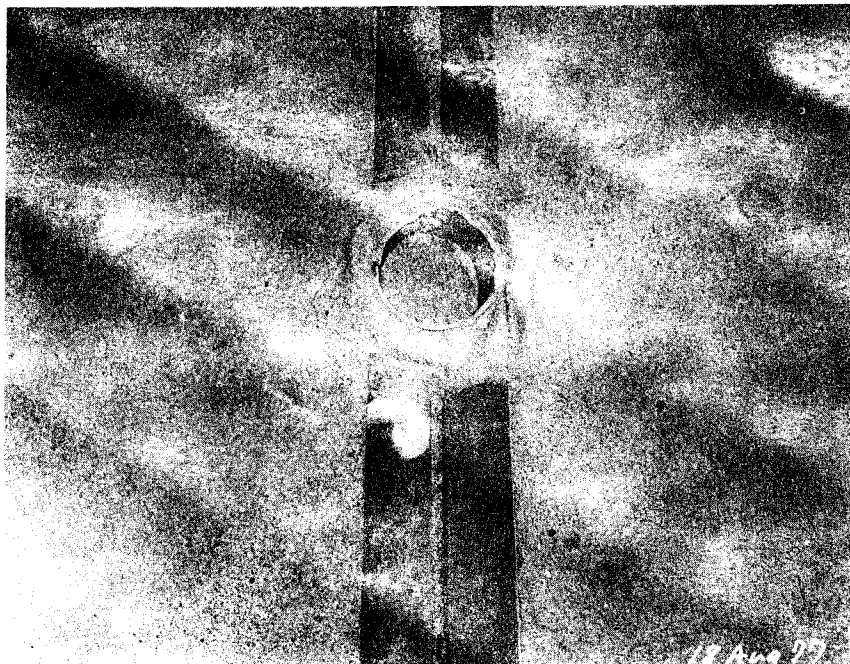
111. The drill hole was filled on 12 August 1977 by discharging the hydrophobic sand directly from the transit mixer into the hole (Figure 39). Approximately 35 cu ft of hydrophobic sand was used. Excess sand was stored at the lock. By 17 August, the sand had settled about 5 ft and the hole was refilled. The sand appeared to settle about 1/4 in. with each lockage (Figure 40). On 24 August, the sand was about 5 in. below the surface and the hole refilled. On 2 September, the sand was down about 9 in. and the hole was again refilled. During October 1977, a 6-in.-diameter hole 118 ft deep was drilled 7 ft from the lock face to be used as an observation well to check the effectiveness of the material as a waterstop. On 29 November, the sand was down about 15 ft in the test hole. When the lock was filled, the water in the observation well rose almost as fast as the water in the lock. When the lock was full, the water was within 15 ft of the deck. The water was also running over the top of the sand in the test hole. The water was running fast enough to be clearly heard and seen flowing through the joint looking down both holes from the deck. Since that time, sand has continued to be washed out of the test hole through the joint into the observation hole.

Figure 40. Settlement of hydrophobic sand in drill hole after three lockages, Ice Harbor Lock

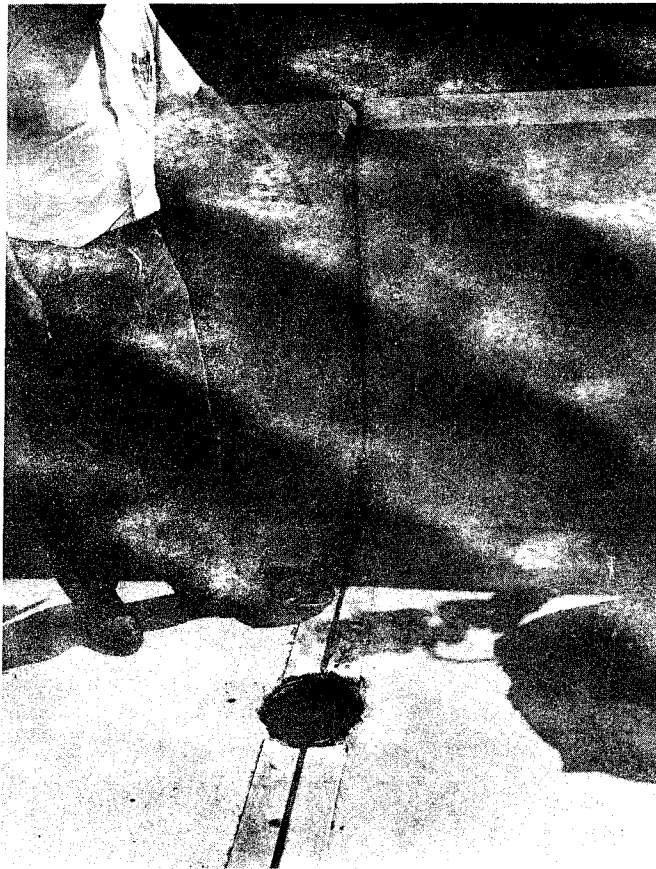
Figure 43. Drill hole filled with acrylamide grout, Ice Harbor Lock

115. The grout still looked good when inspected on 2 September. An observation hole was drilled 4 ft landward of test hole in October 1977. On 29 November 1977, the water level was measured at 95 ft below deck with the lock filled. The water level was below the end of a 100-ft tape before the lock was filled; depth to tailwater was about 108 ft. The AM-9 was still in the test hole to within an inch of the top.

114. The drill hole was grouted on 17 August 1977. The packer was inserted into the hole to about 150 ft below the surface. Two separate solutions of grout materials were mixed (Figure 41) and then pumped separately through two hoses (Figure 42) which were connected to a mixing nozzle suspended below the packer. The grout was pumped in 10-ft stages. This necessitated stopping grout injection while the packer was being moved and then resuming pumping. The top 30 ft of the grout was diluted by water in the hole. This material was removed from the hole using a high-velocity water cleaner and the section of the hole was regouted. Grouting was accomplished while the lock water was at tailwater level. A view of the completed repair is shown in Figure 43.

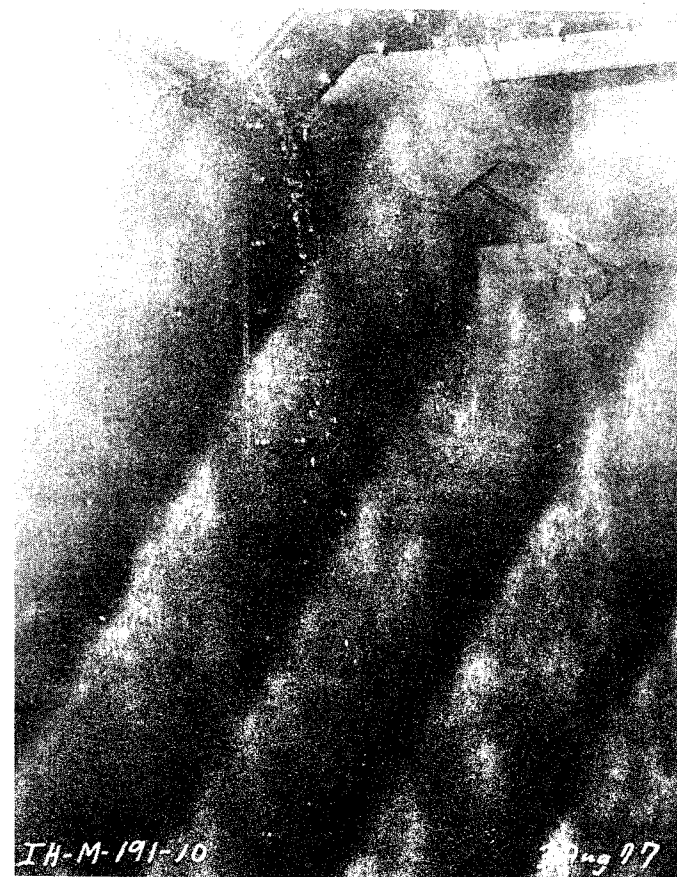
121. In contrast to the last inspection (1974), severe leakage at the joint between the cross-over gallery of the upstream sill and monolith 3 was reported in September 1977. Coupled with problems with the drainage gallery sump pump, this leakage had caused flooding of the drainage gallery to a depth of about 5 ft. Cover plates bolted over the joint (Figure 45) help control the leakage but certainly have not solved the problem. The leakage appeared to be coming from the lock chamber and not from the upstream face of the end sill. If the sump pump were to fail, flooding of the drainage galleries all the way across the powerhouse and ultimately the powerhouse would occur. Therefore, repairs to stop the leakage were recommended.

b. Leakage past the cover plate over the joint

Figure 45. Joint between the cross-over gallery of the upstream sill and monolith 3, Ice Harbor Lock

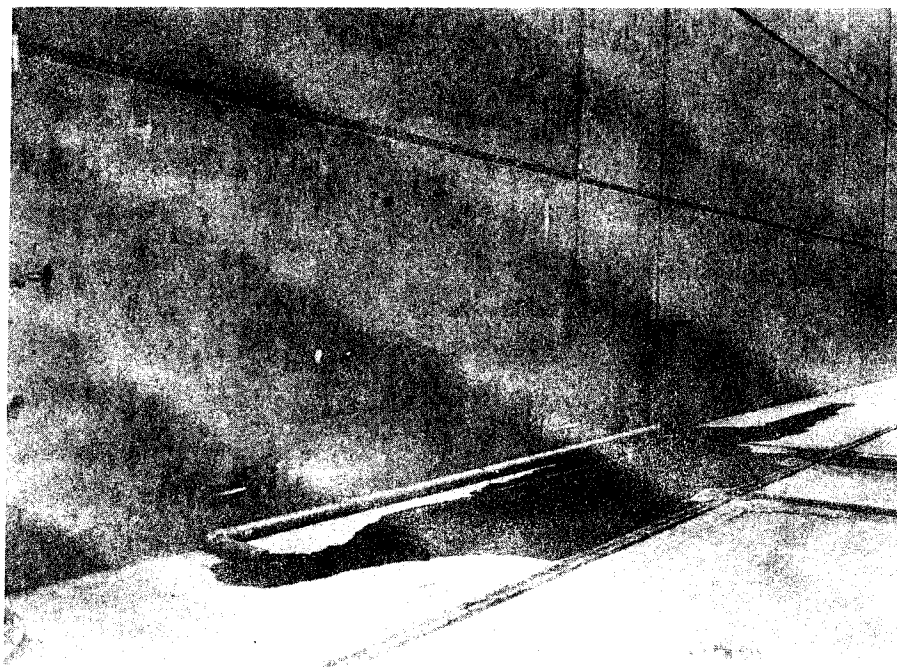
125. Leakage of varying intensities was reported between monolith joints of the different bays in the powerhouse. As would be expected, the amount of leakage varies with the seasons. Garden-type hoses are used at the joints in the powerhouse interior to help divert leakage and control it from flowing onto the generator floor. Joint 1/2 leaks every winter, joint 2/3 has leakage that runs through the hose fairly regularly, and joint 4/5 started leaking when the additional powerhouse units were watered up. Leakage at the outside transformer deck is substantial and is contained in metal troughs and pipes (Figure 47). It was noted that if the pipes were to freeze or if the leakage increased considerably during the winter, a problem of ice buildup and possible flooding of the transformer deck could occur.

Figure 47. Trough and piping to help contain monolith joint leakage in powerhouse, Ice Harbor Dam

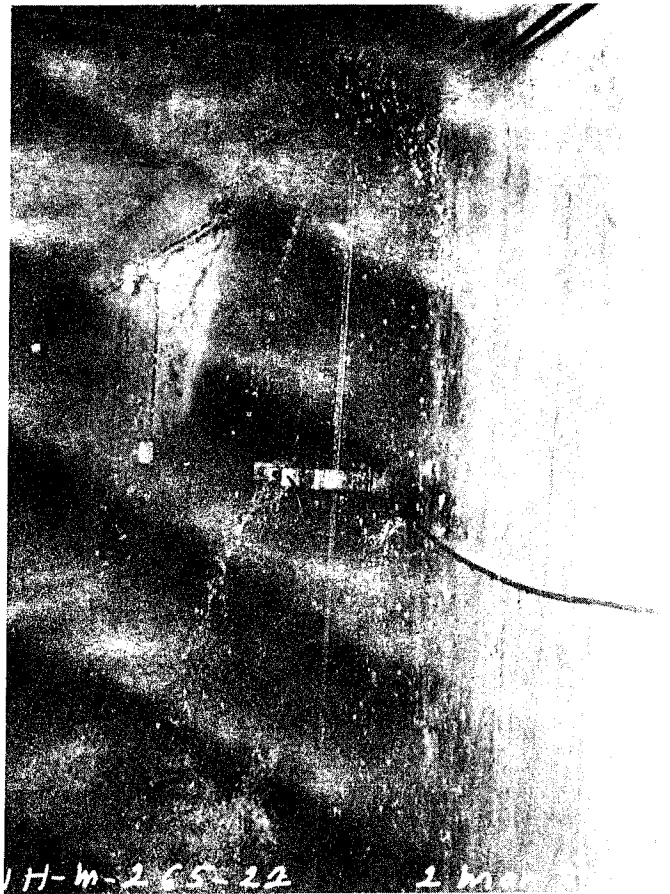
Figure 48. Leakage through joint between
sill block and lock monolith 3, Ice Harbor
Lock

126. Contraction joints between the upstream sill block and the lock monoliths were repaired by contract in FY 79. Leakage into the service and drainage gallery was reduced by drilling a series of EX-size drill holes and chemically grouting the perimeter of the contraction joints at either end of the sill block. Additional drilling and grouting were done around the perimeter of the drainage and service galleries at the same contraction joints to further decrease the inflow of water. The drilling and grouting procedure was initially successful but within a year some of the chemical grout used to form the waterstops had extruded through one contraction joint onto the gallery floor. As a result, this joint exhibited significant leakage (Figure 48). As part of a miscellaneous repair contract, new or modified backup plates will be installed over the joints extruding grout and a new grout formulation will be installed.

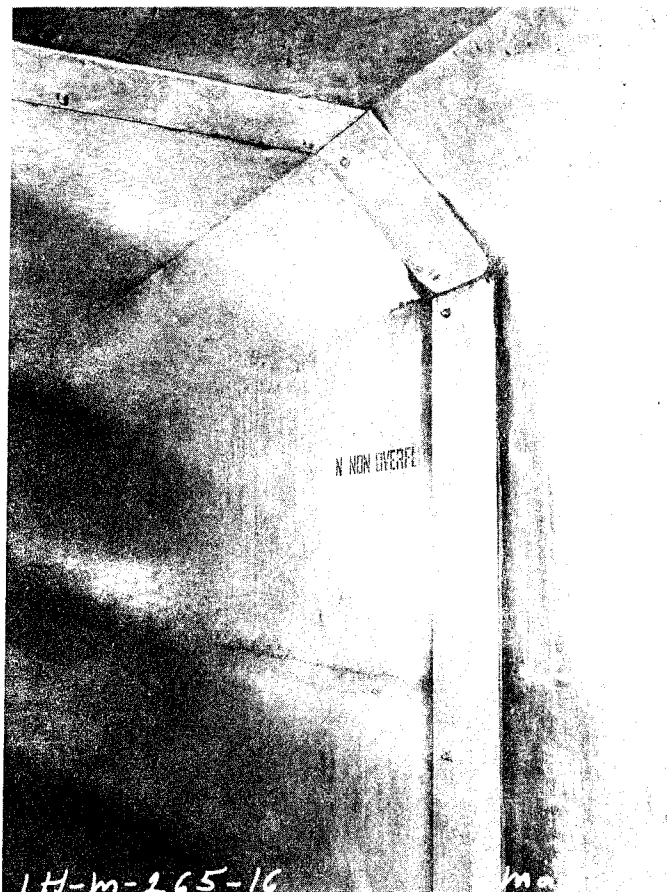
128. Major leakage into the north nonoverflow dam was eliminated by the 1978 installation of chemical grout vertical waterstops similar to those installed in the navigation lock. Backup plates that were installed during the grouting operation are to be replaced in the next repair contract. The plates, which are bolted along one side in one monolith (Figure 50), were bolted so tightly against the neoprene pad behind the plate that the plate was sprung, eliminating any possibility of sealing the joint from water leakage and grout extrusion. It was suggested that the steady water seepage into the

Figure 50. Steel backup plate installed at
nonoverflow monolith joint 1/2, Ice
Harbor Dam

gallery occurring in November 1980 could be eliminated by the installation of an effective backup plate system. Extensometer measurements have been taken since November 1972 to monitor adjacent monolith movement at elevation 453 ft in the nonoverflow dam and powerhouse dam. They indicated relative movements were less than 0.1 in. in November 1980.

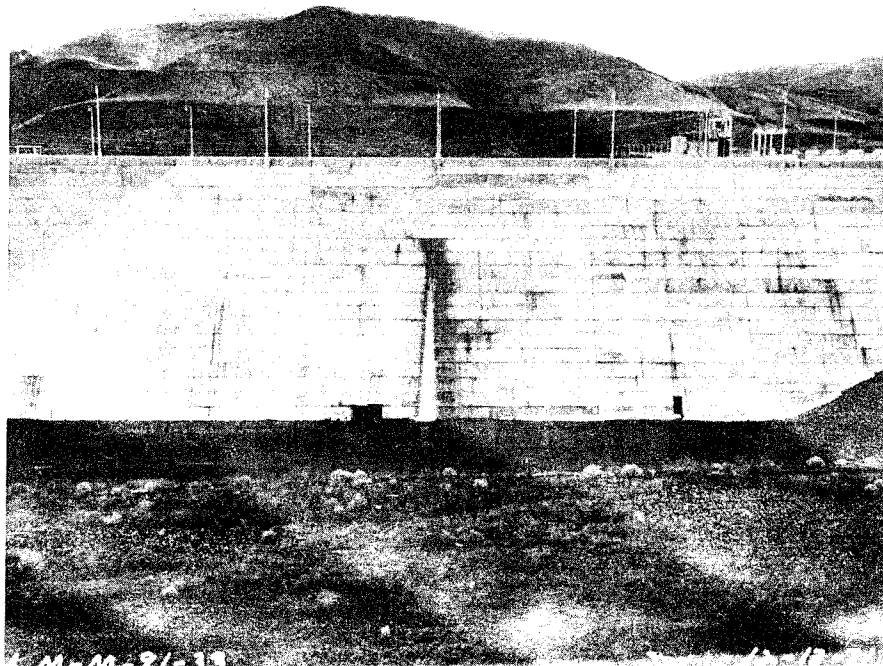
manufactured by Sika Corporation, to form a temporary membrane over areas of deteriorated concrete adjacent to the joint. In September 1971, it was reported that the epoxy showed signs of deterioration and also that the concrete deterioration appeared progressive, as evidenced by increased flows through joints 26/28, 25/27, and 18/20 (Figure 55).

Figure 55. Leakage through joint 18/20 with full lock
chamber, Lower Monumental Lock, December 1971

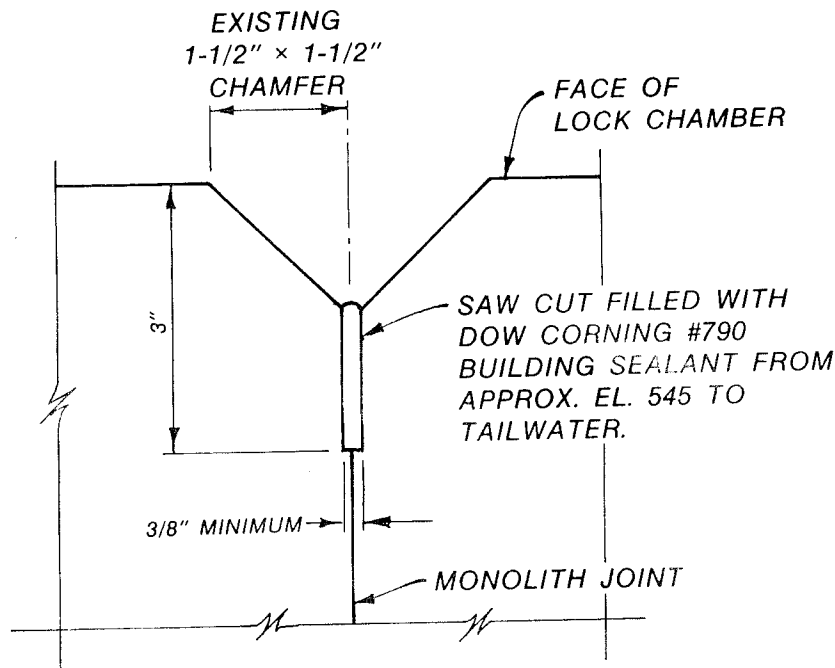
Figure 56. Caulked joint repairs, Lower Monumental Lock

significantly in the past and was repaired by District personnel in March 1975. A groove $\frac{3}{8}$ in. wide and $1\frac{1}{2}$ in. deep was sawed along the joint and filled with Dow Corning 790 building sealant (Figure 56). The sealant was applied during a period when the lock was out of operation for approximately 24 hr. Cost of the repair was approximately \$2,000. The sealant was tightly bonded and totally filled the sawed groove which was inspected during the December 1976 condition survey. However, there was some leakage through the joint from elevation 470 ft to the ground. Since the sealant was only applied down to the existing tailwater elevation, the leakage may have been coming through the joint below this level. Regardless of the reason, the leakage was much less than occurred prior to installing the sealant.

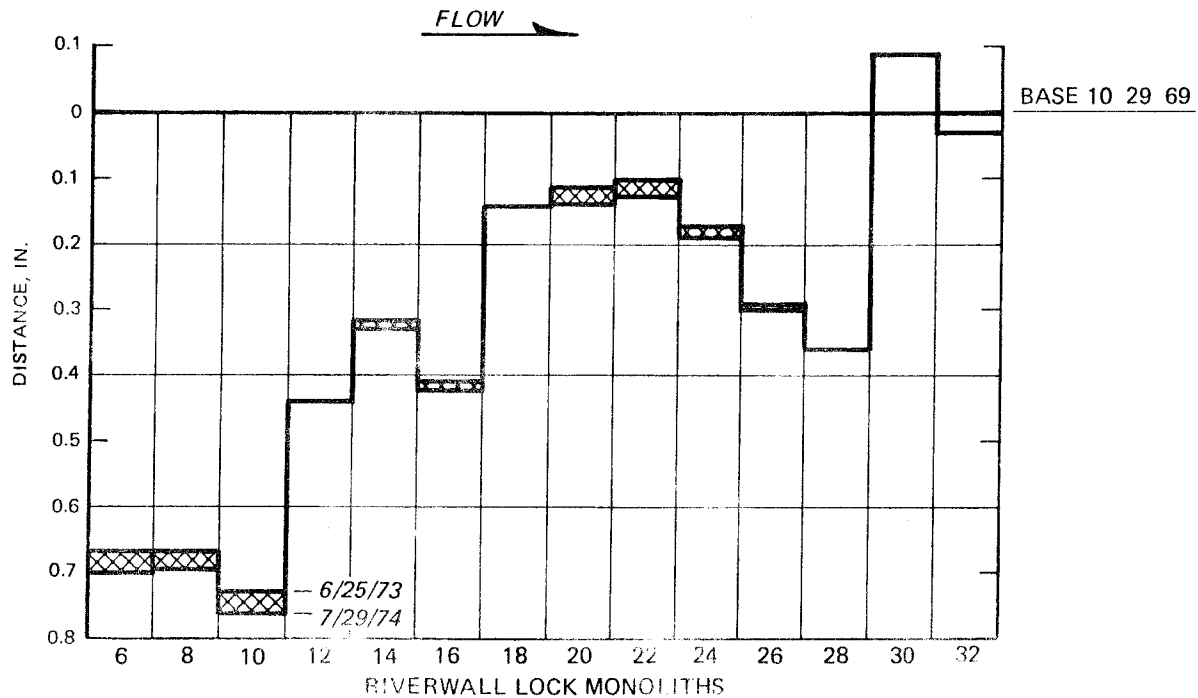
147. Subsequent deflection measurements indicated continued outward tilting of the riverside lock monoliths. Maximum permanent deflections, measured by extensometers, of more than 0.7 in. (Figure 61) were reported in 1974. Displacements were attributed to compression of the relatively weak flow breccia stratum underlying the wall buttresses. The largest relative displacements occurred at monolith joints 4/6, 10/12, 16/18, and 28/30

Figure 61. Permanent deflections measured with lock chamber empty, Little Goose Lock
